AN EXCELLENT IMPRESSION

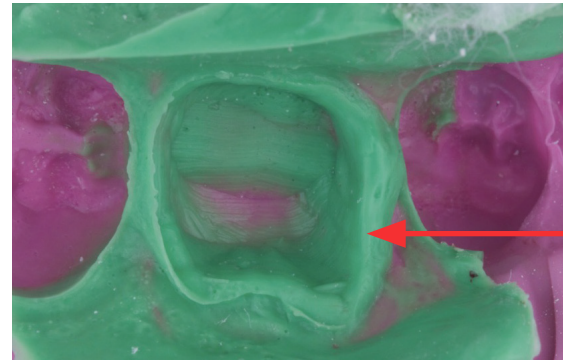
INADEQUATE MARGINS

- Incomplete sulcular expansion around the preparation
- Improper moisture control around the preparation
- Exceeding the material's working time
- Tray movement after seating

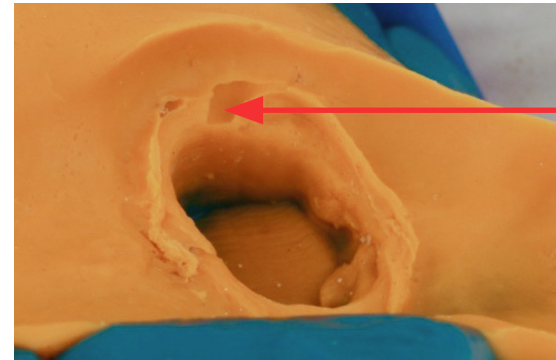
VOIDS

- Improper syringe technique
- Sulcular fluid/bloods/contaminants
- Incomplete sulcular expansion around the preparation
- Tray incorrectly seated
- Insufficient preparation covered by the impression material

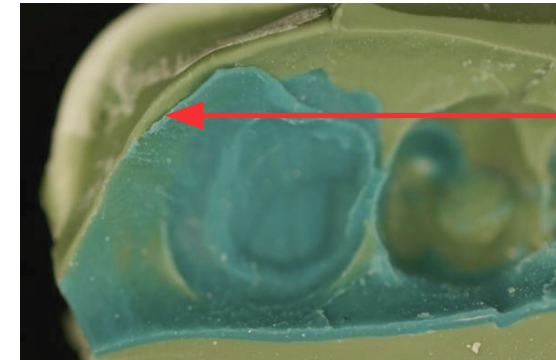
DEBONDING

- Exceeding the material's working time
- Contamination of tray material
- Impression material stored at a temperature above manufacturer's recommendation

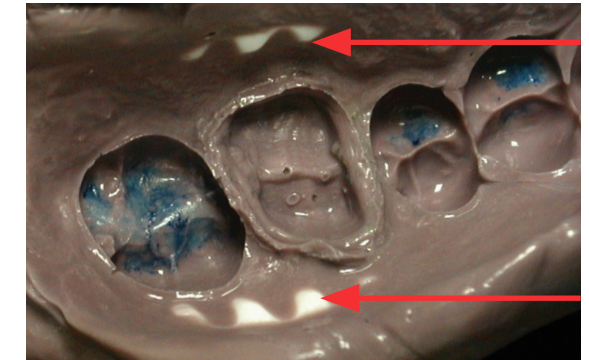
TRAY CONTACT

- Incorrect tray size used
- Tray not oriented correctly
- Insufficient impression material used

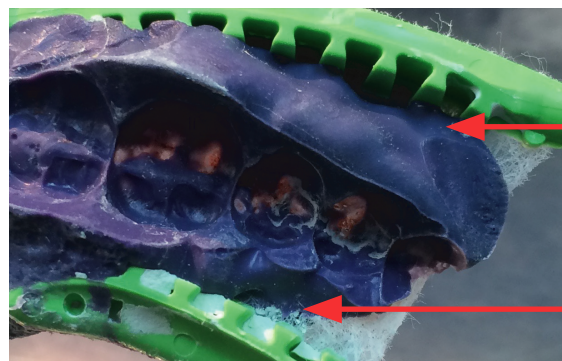
INADEQUATE IMPRESSION RETENTION

- Insufficient impression material used
- No tray adhesive used
- Inadequate tray adhesive drying time
- Outdated impression material used

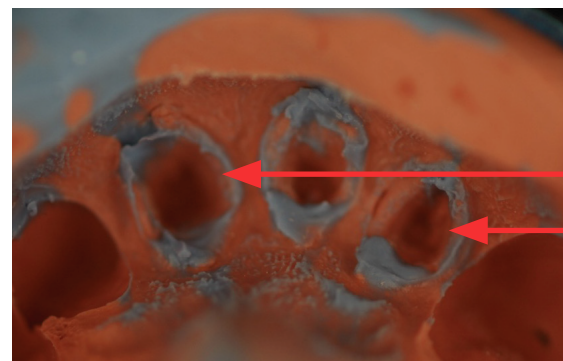
TEARING OF WASH MATERIAL

- Insufficient retraction around the preparation
- Impression removed before material has set
- Improper moisture control around the preparation
- Outdated impression material us

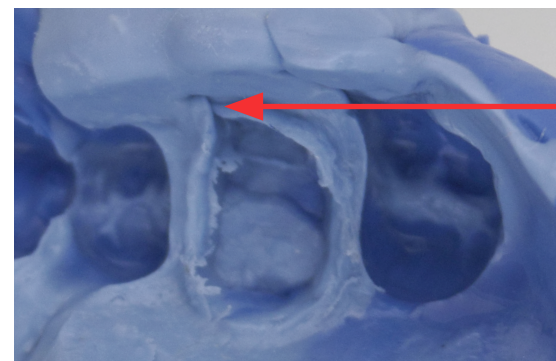
PULLS

- Exceeding the material's working time
- Tray movement after seating the impression
- Insufficient impression material used
- Rapid seating of the impression tray

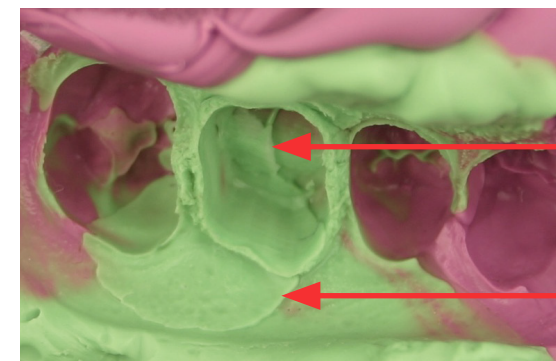
LEDGES

- Preparation of most posterior tooth is contraindicated with dual-arch trays
- Buccal, lingual and posterior tray contact
- Lack of occlusal clearance
- Extreme mesh exposure

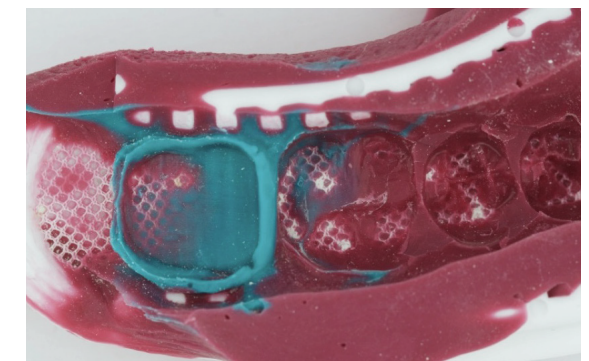
TRAY ISSUES

- Incomplete sulcular expansion around the preparation
- Improper moisture control around the preparation
- Exceeding the material's working time
- Tray movement after seating
